CCTV Inspection Report

Metro Rod (Mid Wales & Shropshire)

Job Number
1325665

CAERSWS VILLAGE TOILETS
CAERSWS
POWYS
SY17 5DT

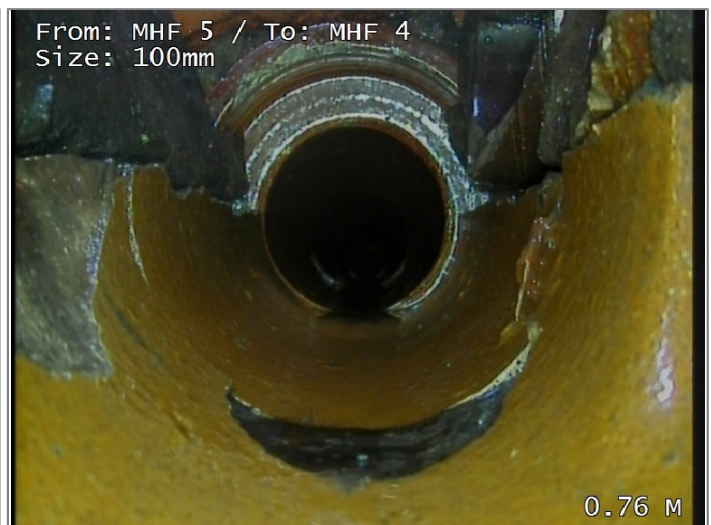
Joint displaced medium - Remark: ROUGH LARGE GAP FROM CLAY TO CLAY

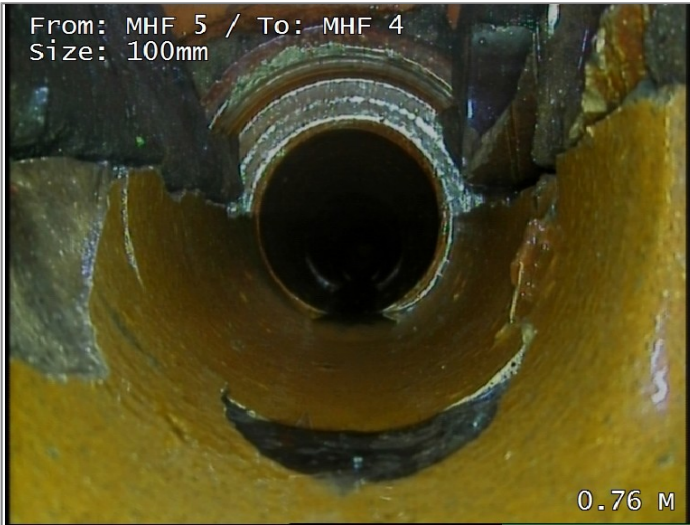
Hole in drain/sewer at 6 o'clock

Structural Defects			
Section	PLR	Grade	Fault Description
2	MHF 5 X	4	Hole in drain/sewer at 6 o'clock
7	MHF 4 X	3	Cracks multiple from 12 to 12 o'clock
8	MHF 3 X	3	Cracks multiple from 12 to 12 o'clock
			Cracks multiple from 12 to 12 o'clock
			Cracks multiple from 12 to 12 o'clock
			Cracks multiple from 12 to 12 o'clock
9	UNKNOWN X	3	Cracks multiple from 12 to 12 o'clock
			Cracks multiple from 12 to 12 o'clock
10	MHF 2 X	3	Cracks multiple from 12 to 12 o'clock

Grade 4; Best practice suggests consideration to be given to repair to avoid potential collapse.

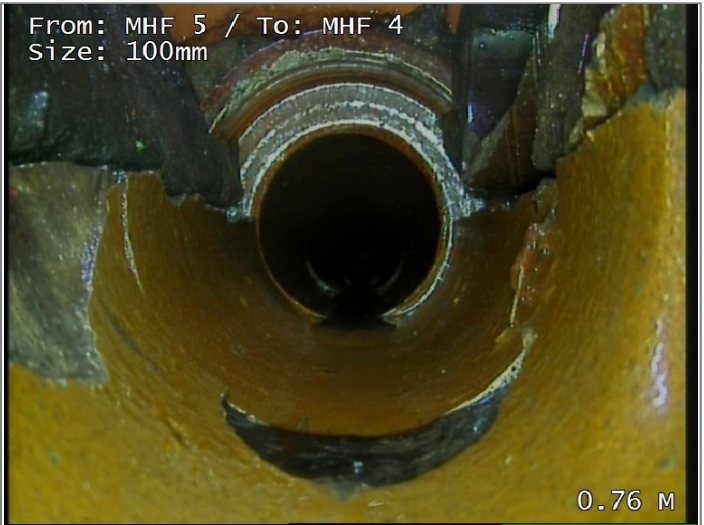
HOLE AND CRACK IN MAIN CHANNEL

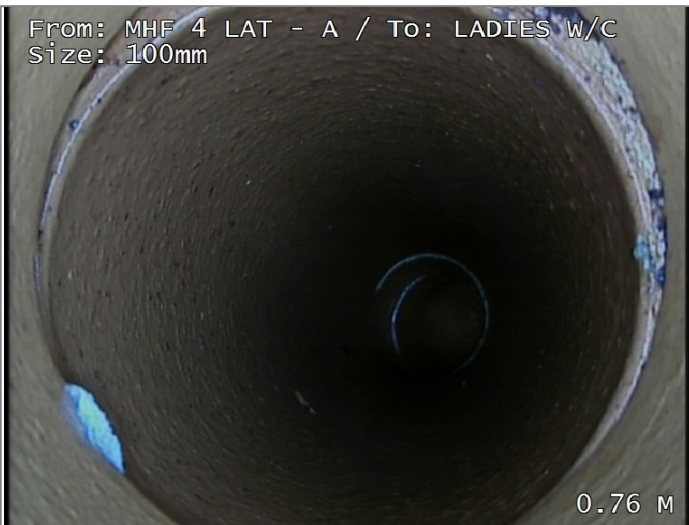
Joint displaced medium - Remark: TISSUE CATCHING

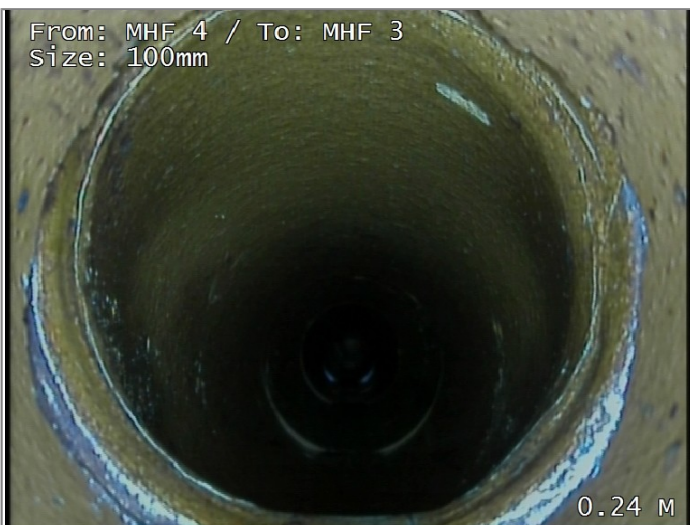
Cracks multiple from 12 to 12 o'clock

Grade 3; Best practice suggests consideration to be given to repair in the medium term.

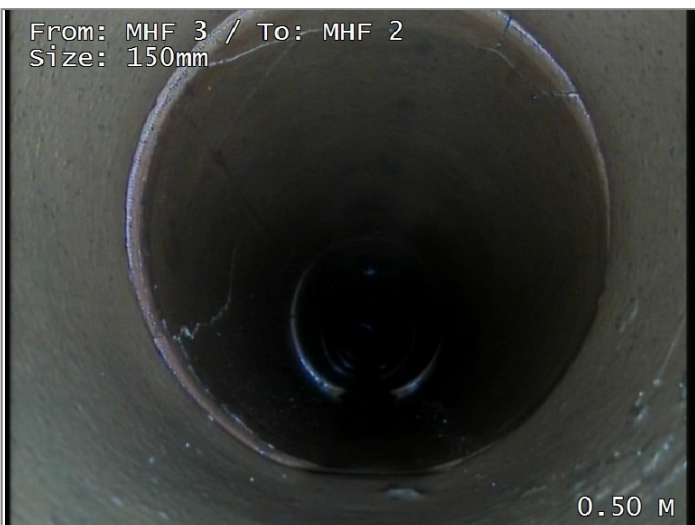
Cracks multiple from 12 to 12 o'clock

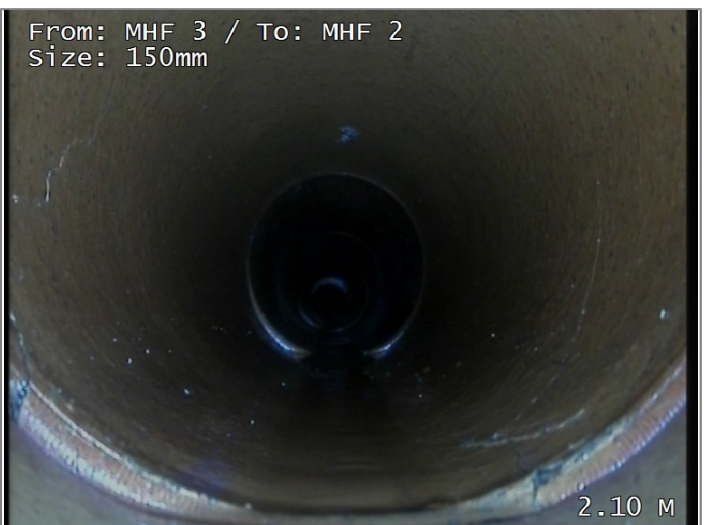
Cracks multiple from 12 to 12 o'clock

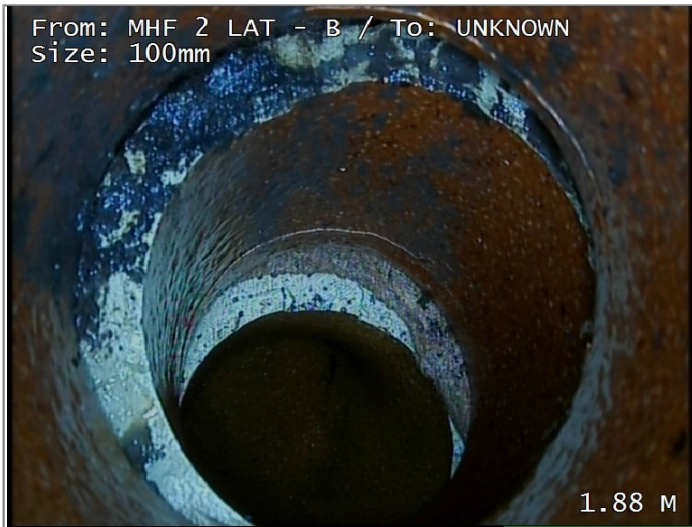
Joint displaced large

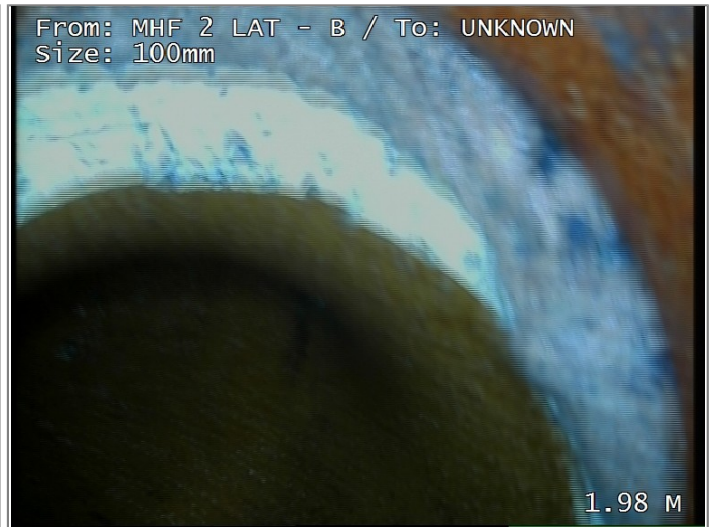
Joint displaced large

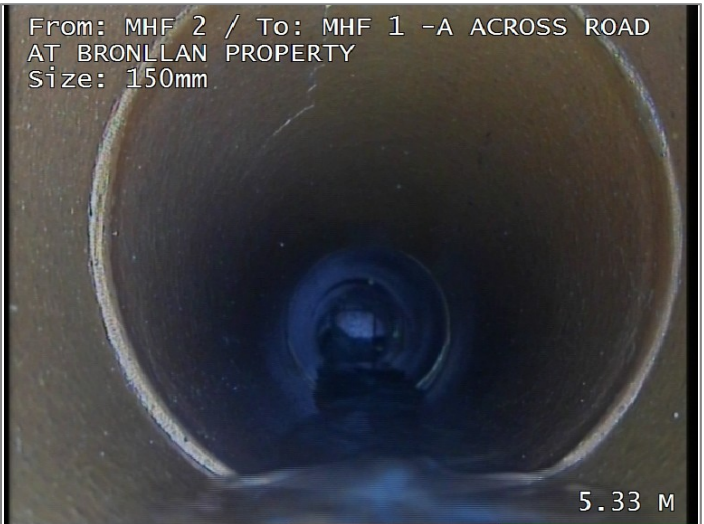
Crack longitudinal at 12 o'clock

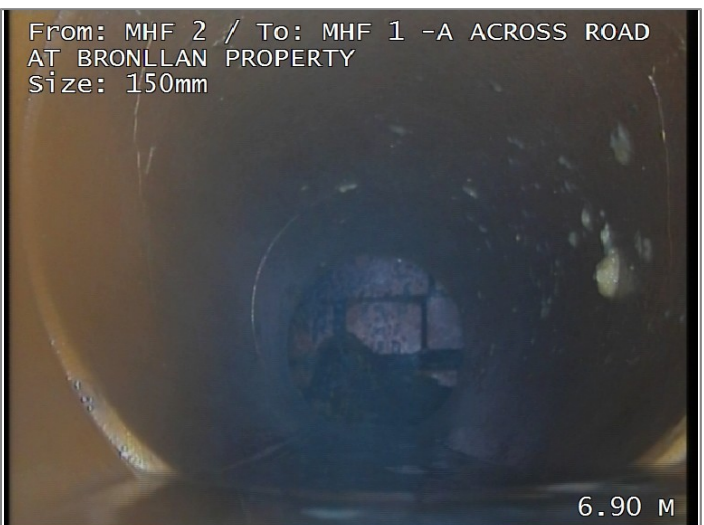
Cracks multiple from 12 to 12 o'clock
