CCTV Inspection Report

Metro Rod (Mid Wales & Shropshire)

Job Number
1325665

CAERSWS VILLAGE TOILETS
CAERSWS
POWYS
SY17 5DT

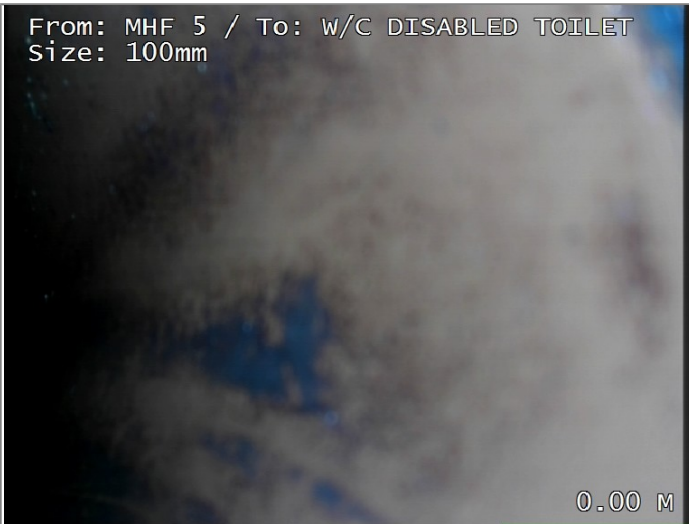
Line of drain/sewer deviates left

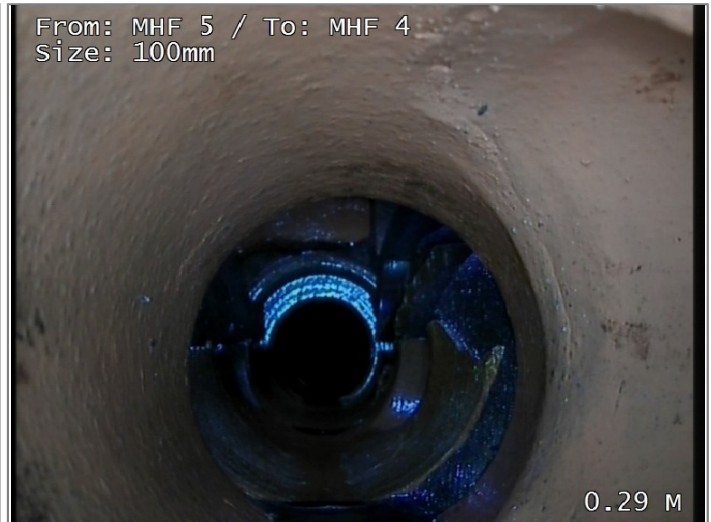
Junction at 3 o'clock, diameter 100mm - Remark: JUNCTION FOR GENTS W/C

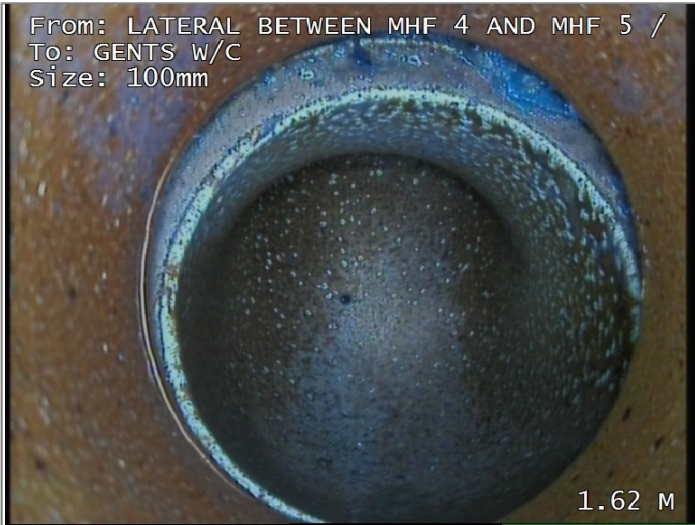
Joint displaced medium

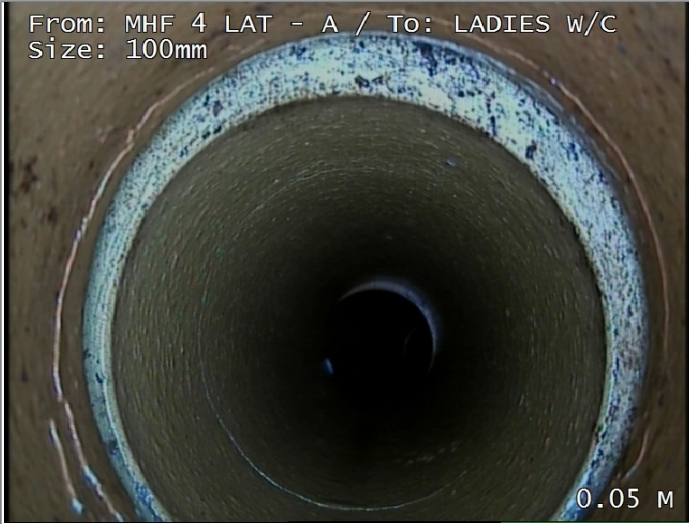
Crack circumferential from 12 to 12 o'clock

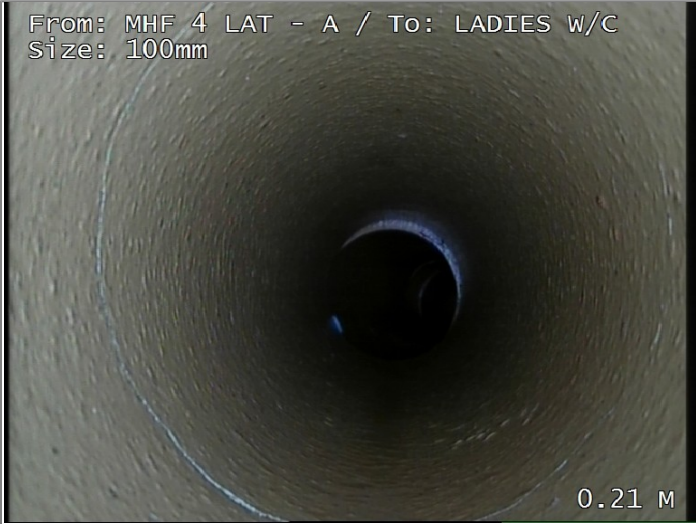
Crack circumferential from 12 to 12 o'clock

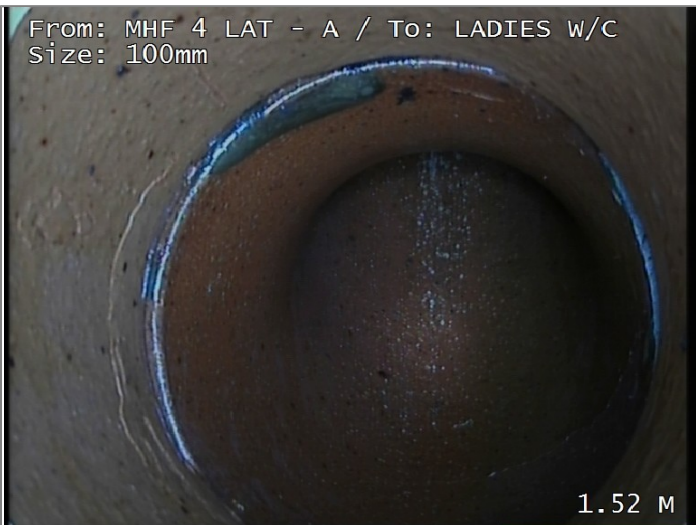
Crack circumferential from 6 to 12 o'clock

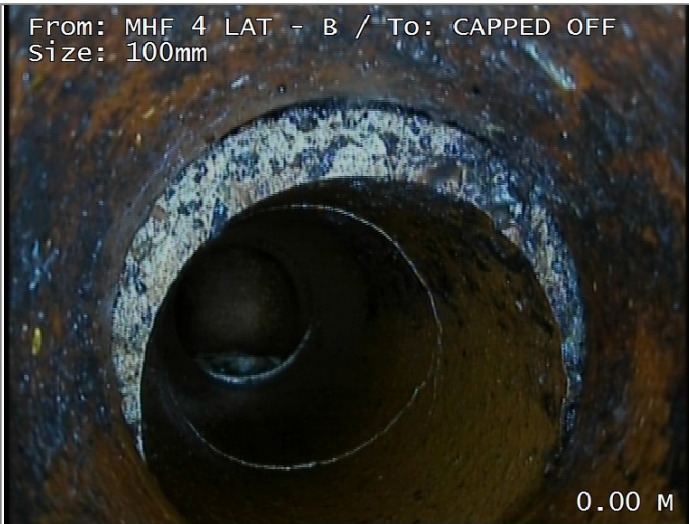
Joint displaced medium

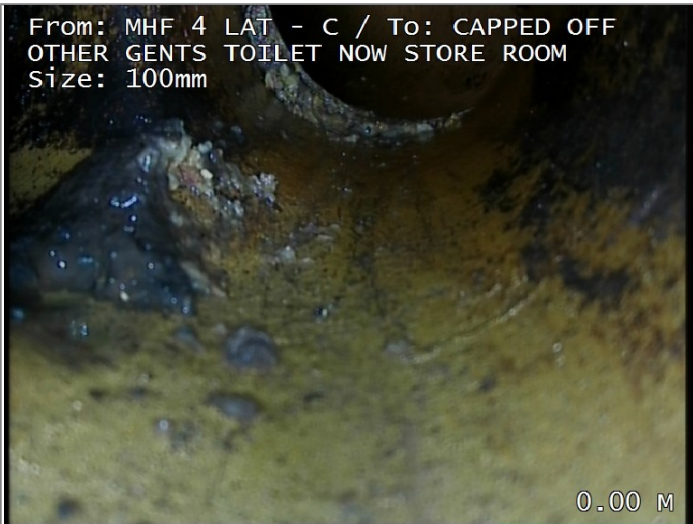
Junction at 9 o'clock, diameter 100mm - Remark: SVP JUNCTION

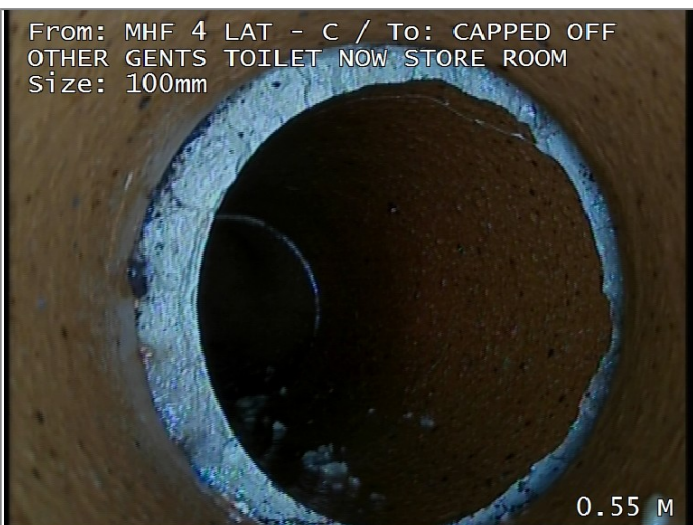
Joint displaced medium

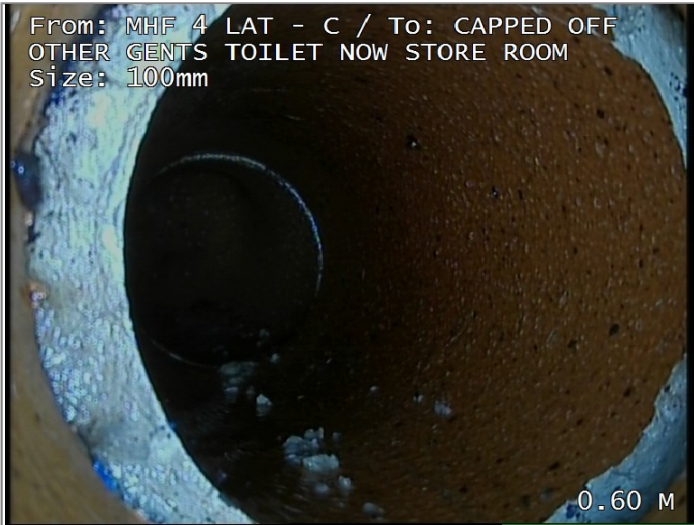
Crack circumferential from 10 to 2 o'clock

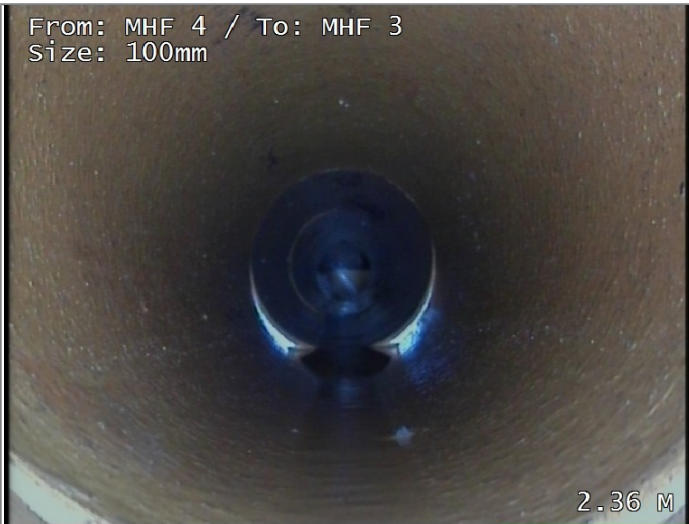
Crack circumferential from 8 to 12 o'clock

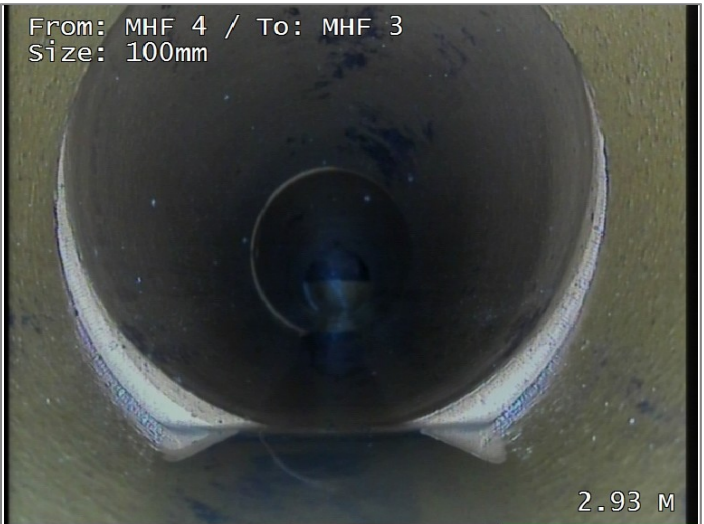
Joint displaced medium

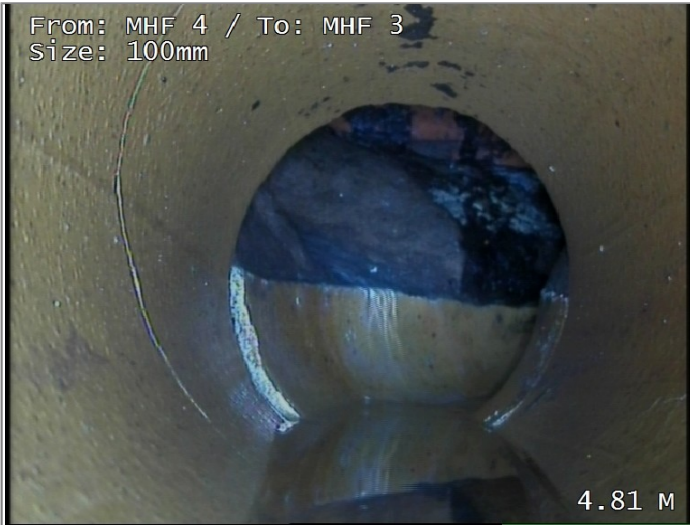
Crack circumferential from 12 to 12 o'clock

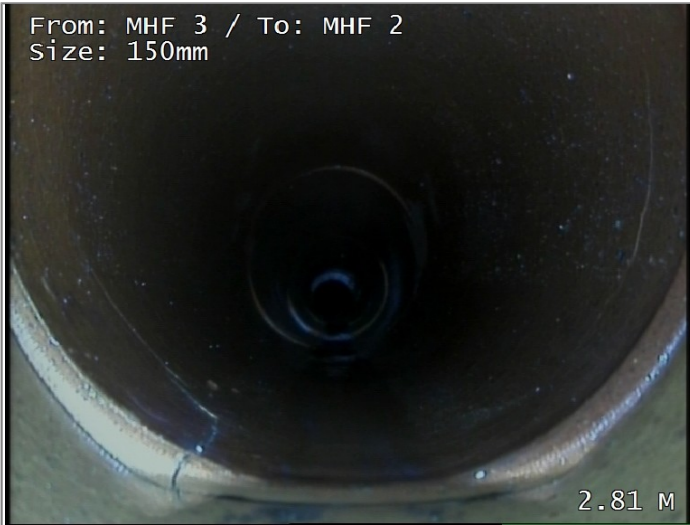
Cracks multiple from 12 to 12 o'clock

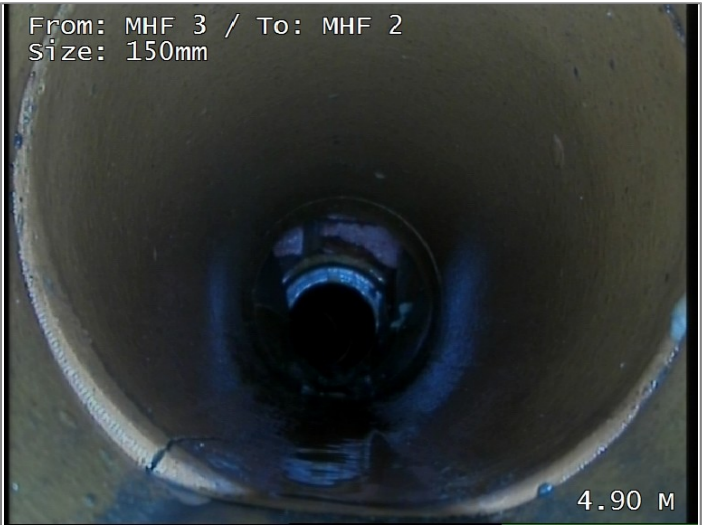
Cracks multiple from 12 to 12 o'clock

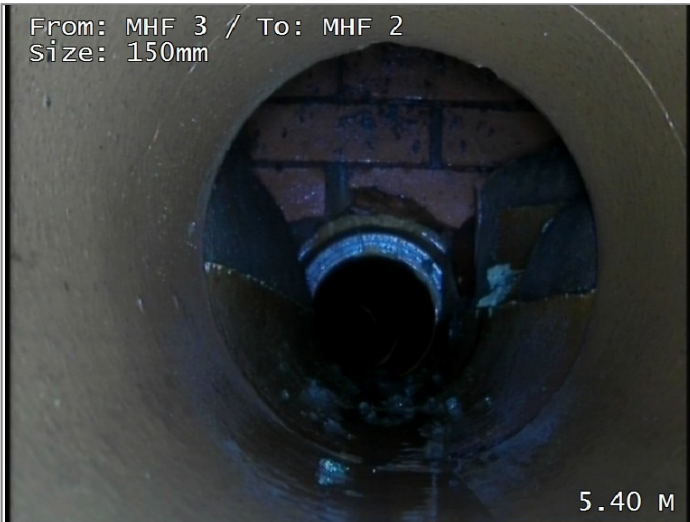
Crack circumferential from 12 to 12 o'clock

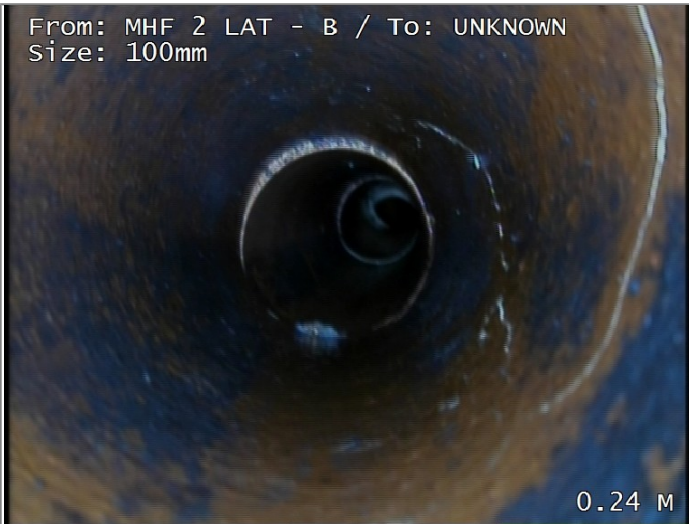
Cracks multiple from 12 to 12 o'clock

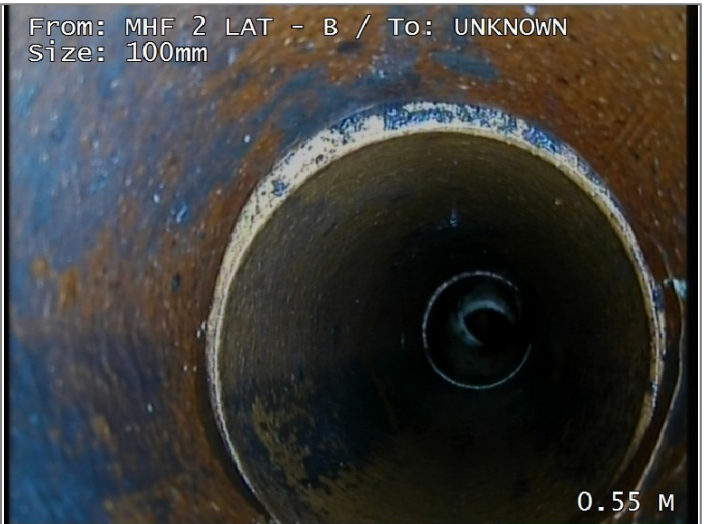
Cracks multiple from 12 to 12 o'clock

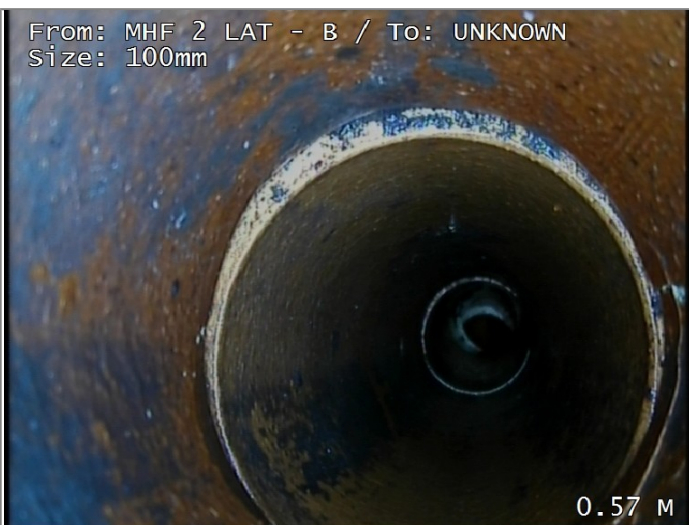
Joint displaced medium

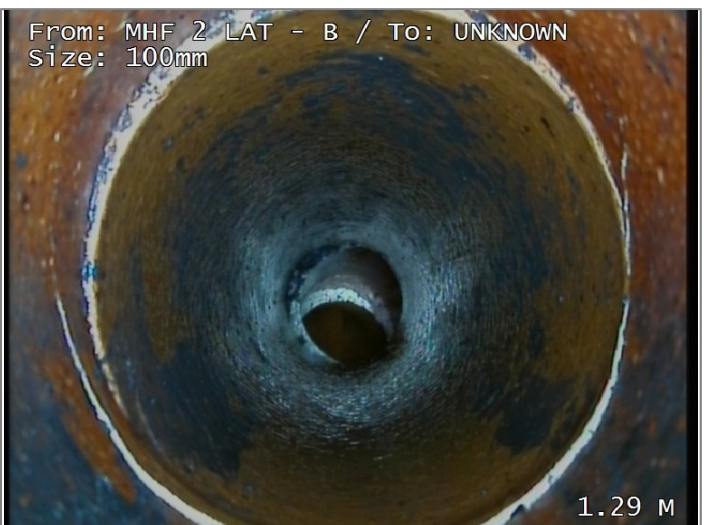
Crack circumferential from 2 to 10 o'clock

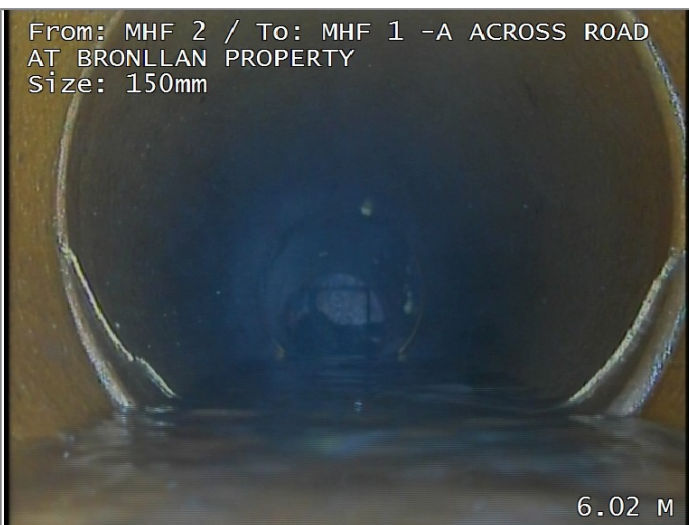
Crack circumferential from 3 to 9 o'clock

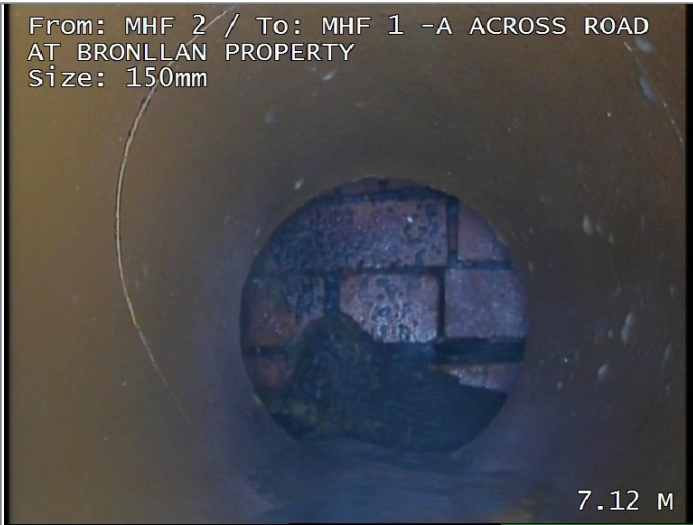
Crack circumferential from 12 to 12 o'clock

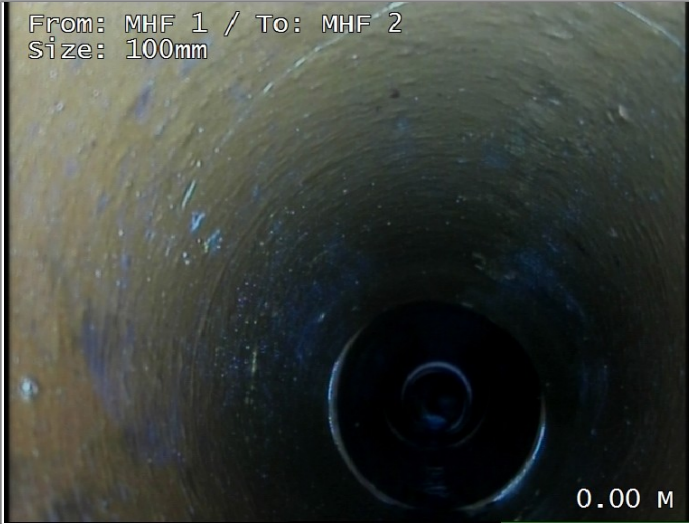
Crack circumferential from 12 to 12 o'clock

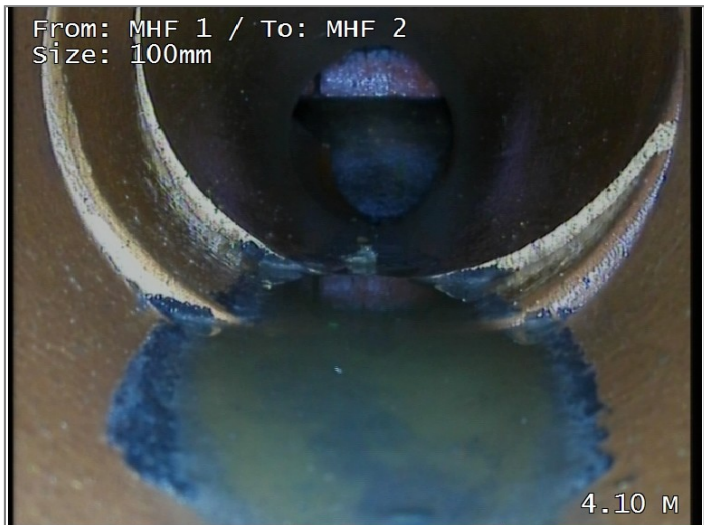
Crack circumferential from 2 to 10 o'clock

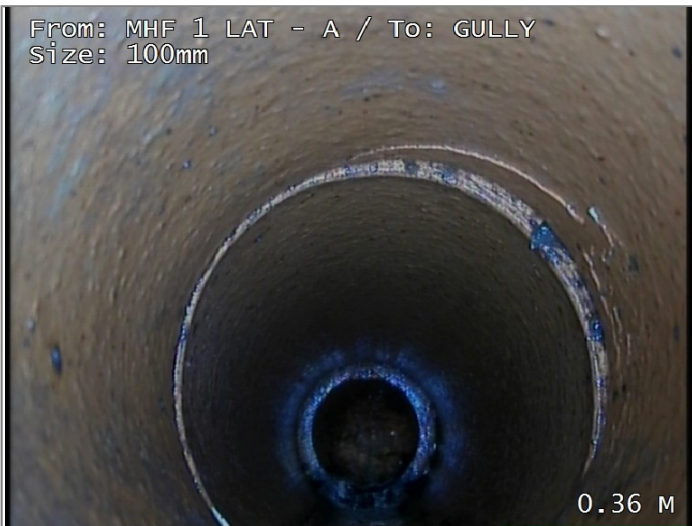
Crack circumferential from 12 to 12 o'clock

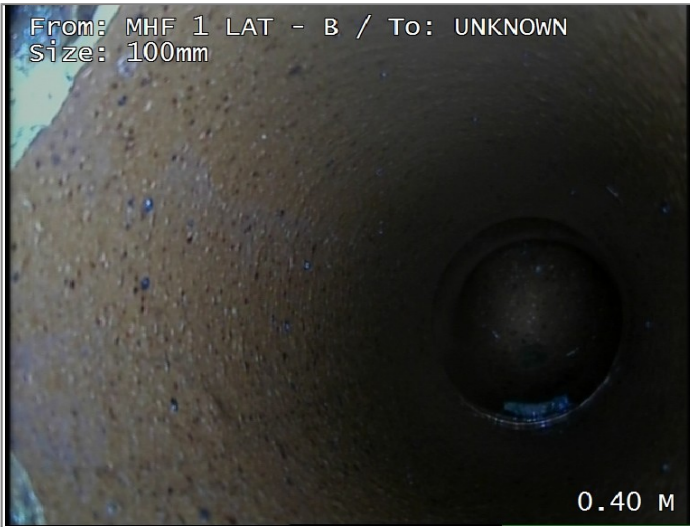
Line of drain/sewer deviates right

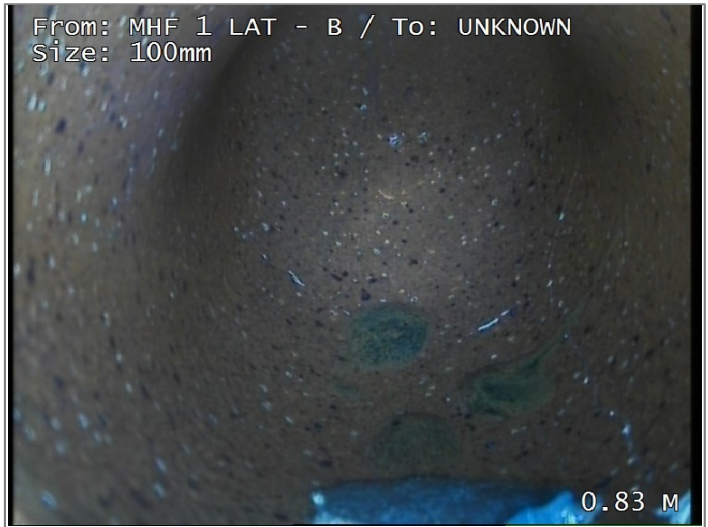
Line of drain/sewer deviates up

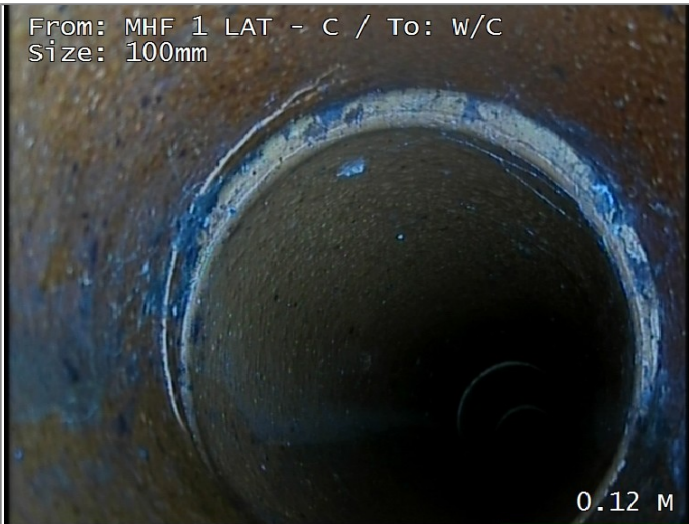
Crack circumferential from 12 to 12 o'clock

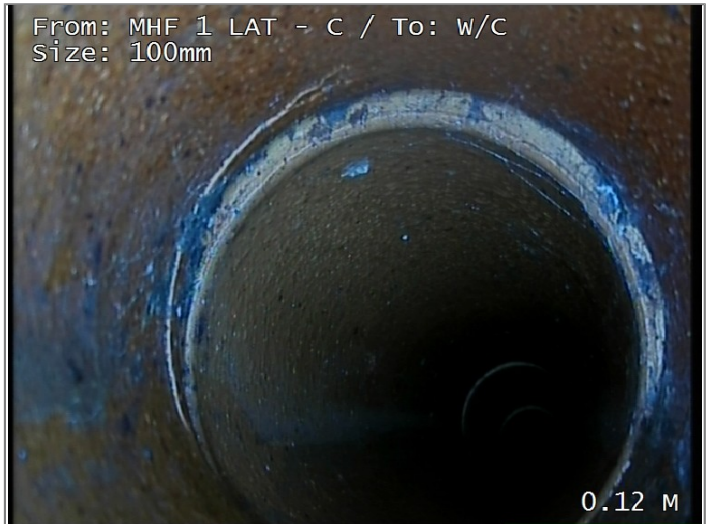
Line of drain/sewer deviates right

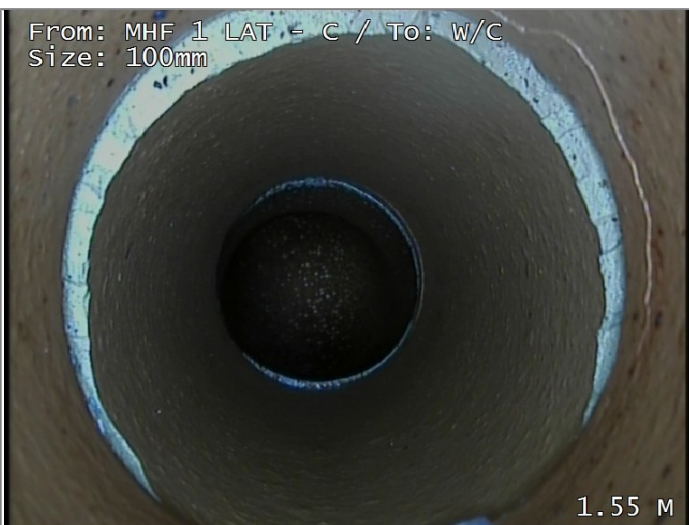
Crack circumferential from 12 to 12 o'clock

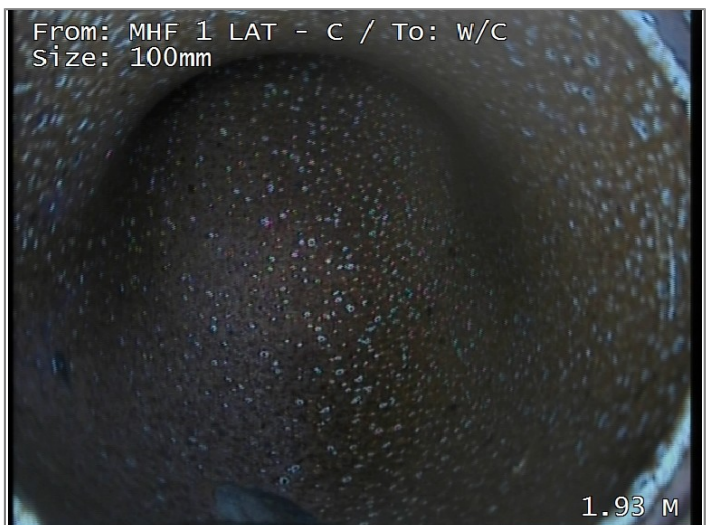
Line of drain/sewer deviates up

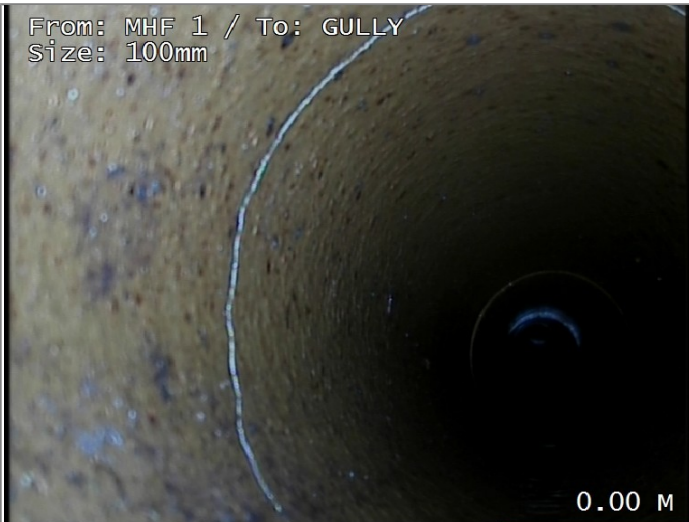
Crack circumferential from 12 to 12 o'clock

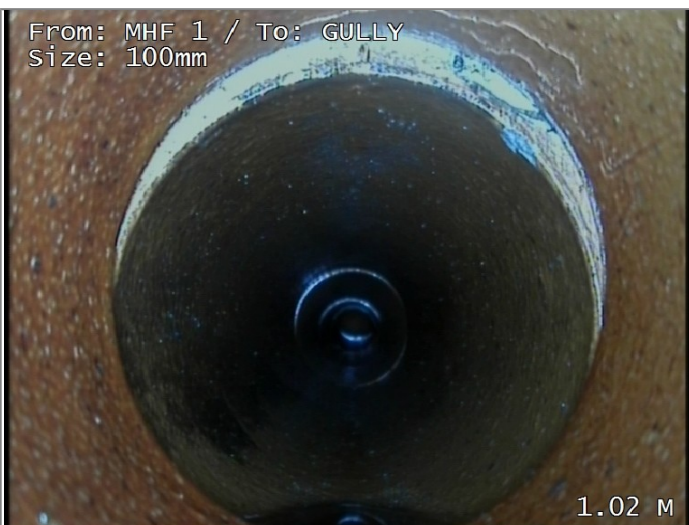
Crack circumferential from 12 to 12 o'clock

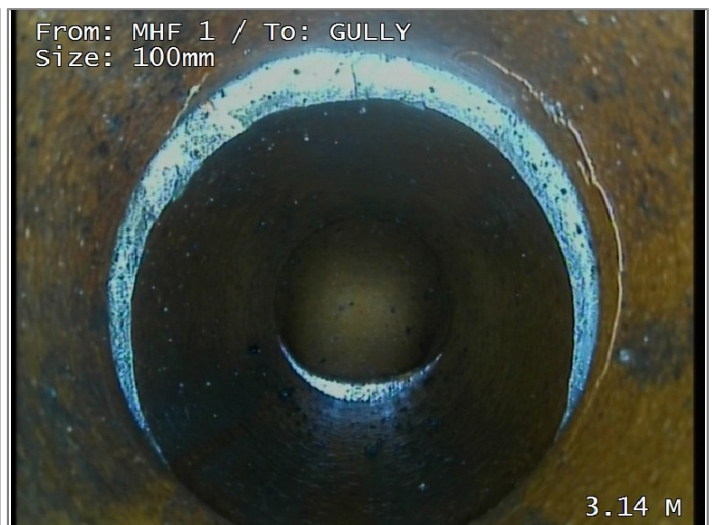
Joint displaced medium

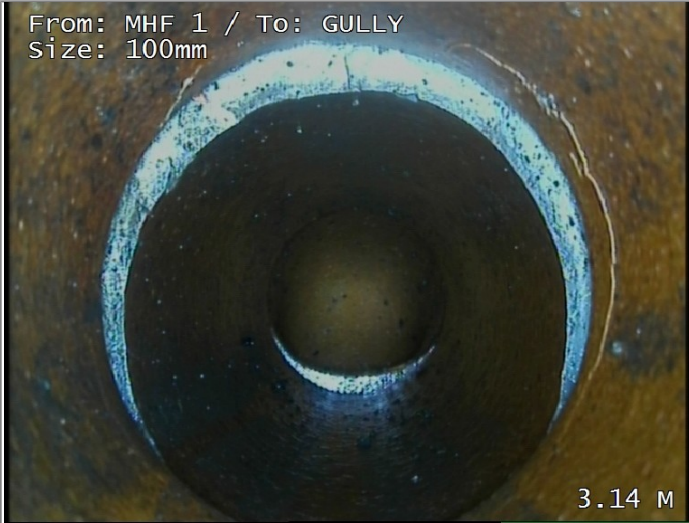
Crack circumferential from 12 to 12 o'clock
