CCTV Inspection Report

Metro Rod (Mid Wales & Shropshire)

Job Number
1325665

CAERSWS VILLAGE TOILETS
CAERSWS
POWYS
SY17 5DT

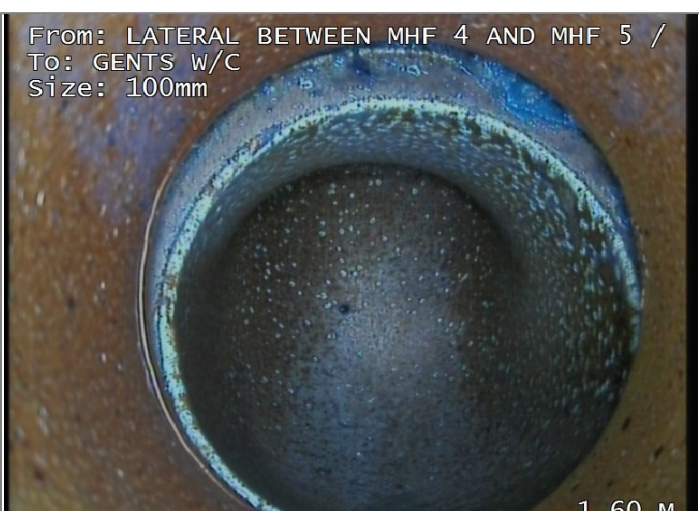
<p>1.60 M</p>	
<p>Joint displaced medium</p>		<p>Crack circumferential from 6 to 11 o'clock</p>

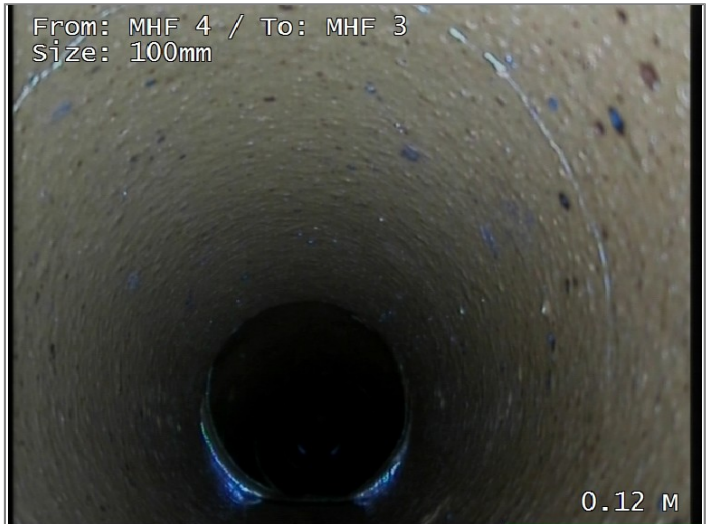
From: MHF 4 / To: MHF 3
Size: 100mm

Crack circumferential from 12 to 12 o'clock

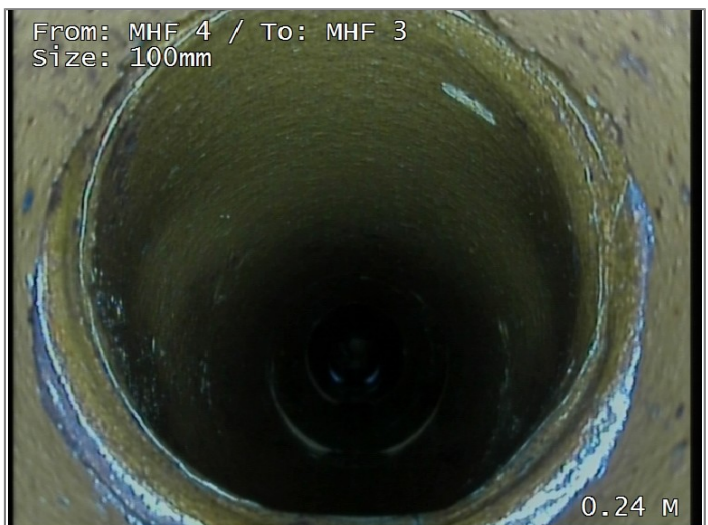
From: MHF 4 / To: MHF 3
Size: 100mm

Joint displaced medium
